BRISTOL
&
AVON
ARCHAEOLOGY

BRISTOL & AVON ARCHAEOLOGY 10 1992

EXCAVATION AT WATER LANE, BY TEMPLE CHURCH, BRISTOL 1971

An excavation in 1971 on the south side of Water Lane and just north of Temple Church (ST 593727) uncovered a small part of the remains of a building probably associated with the round church of the Knights Templar, excavated in 1960. This was replaced by a larger building during subsequent occupation of the site by the Knights Hospitaller. Two almost complete (in plan) buildings and part of a third, built during the Hospitaller occupation and standing until the mid 20th century, were investigated. These provided evidence of industrial as well as domestic activity. A late 18th-19th century limekiln was also recorded.

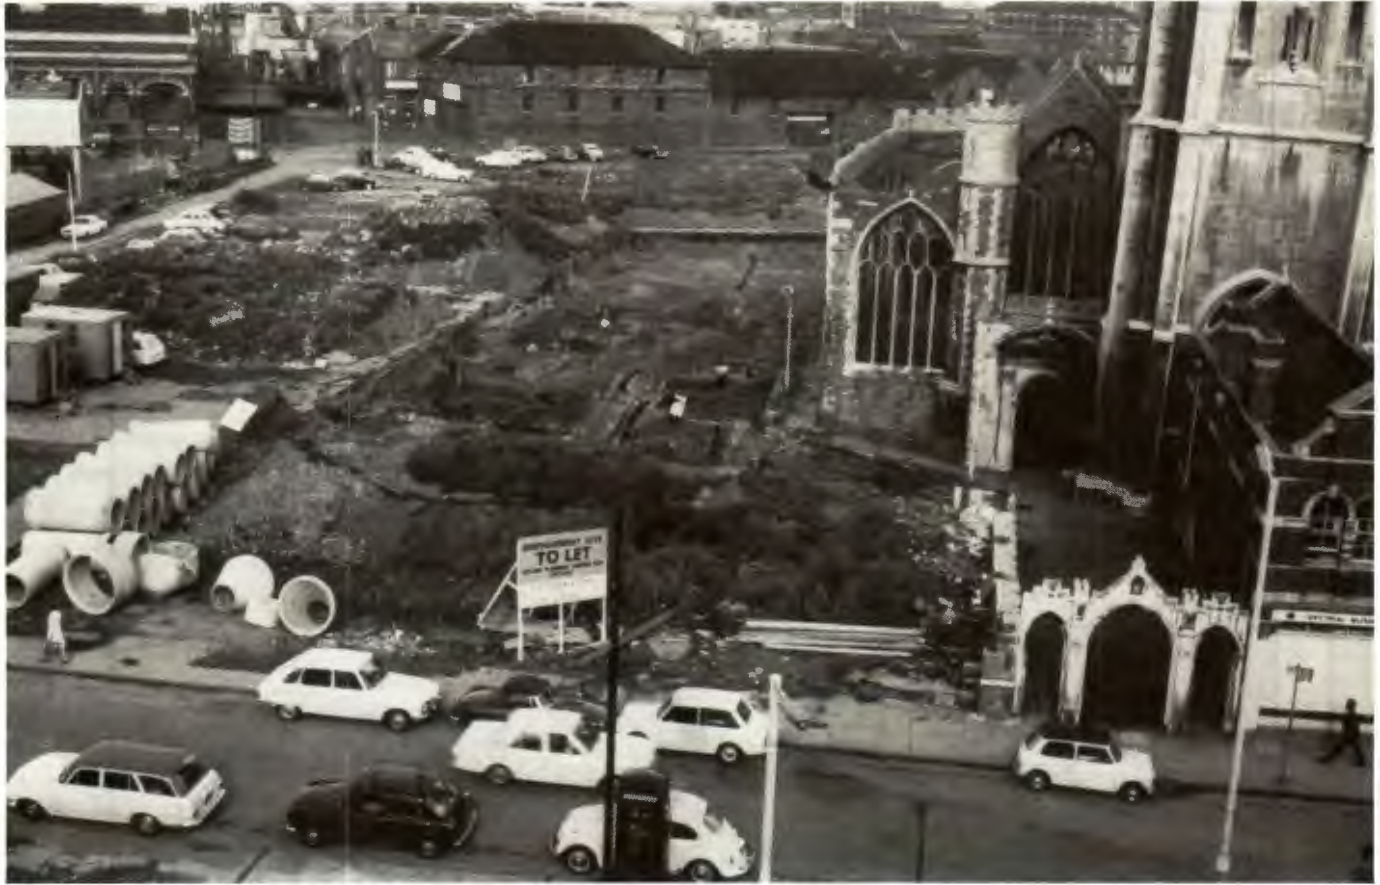
Fig. 3 View of the excavation from the west, with Temple Church on the right and Temple Street in the foreground.

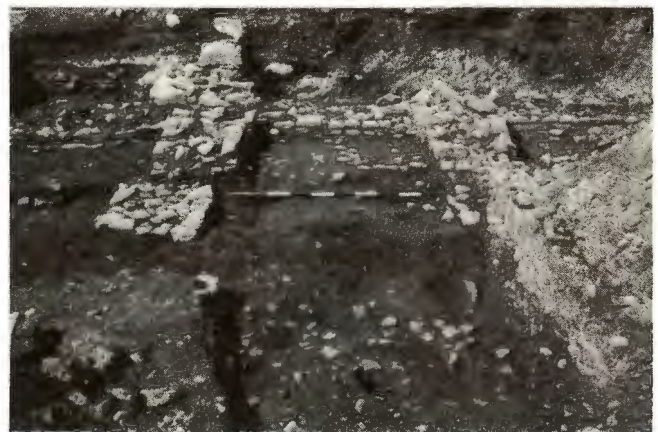
Fig. 4 The porch of the Hospitaller hall from the south. Scale 2m.

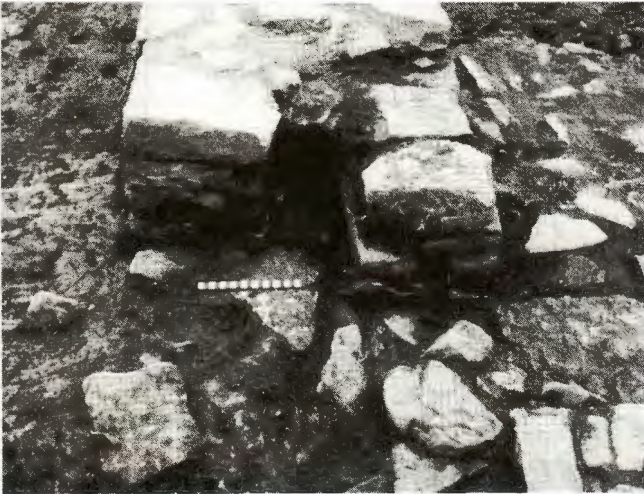
Fig. 7 Building B1. Phase 1. Door jamb post-hole, PH63, at the north side of the entrance to the south room. Scale 20cms.

here only parts of it survived. A post-hole, PH63, at the north side of the entrance marked the position of the door jamb, and the rebate in the face across the wall demonstrated that the door opened inwards (Fig. 7).

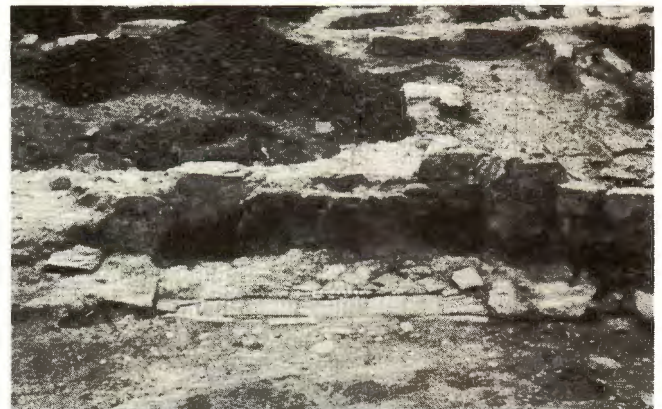
Fig. 12 Building B1. Phase IV — Hearth, H4, from the east. Scale 20cms.

Apparently contemporary with this was the hearth (H4) set into W1 (Fig. 12), but it is difficult to see how the two could have functioned together, since the path passed so close to the hearth. The intensity of burning of the stones, however, showed that it was used a great deal.

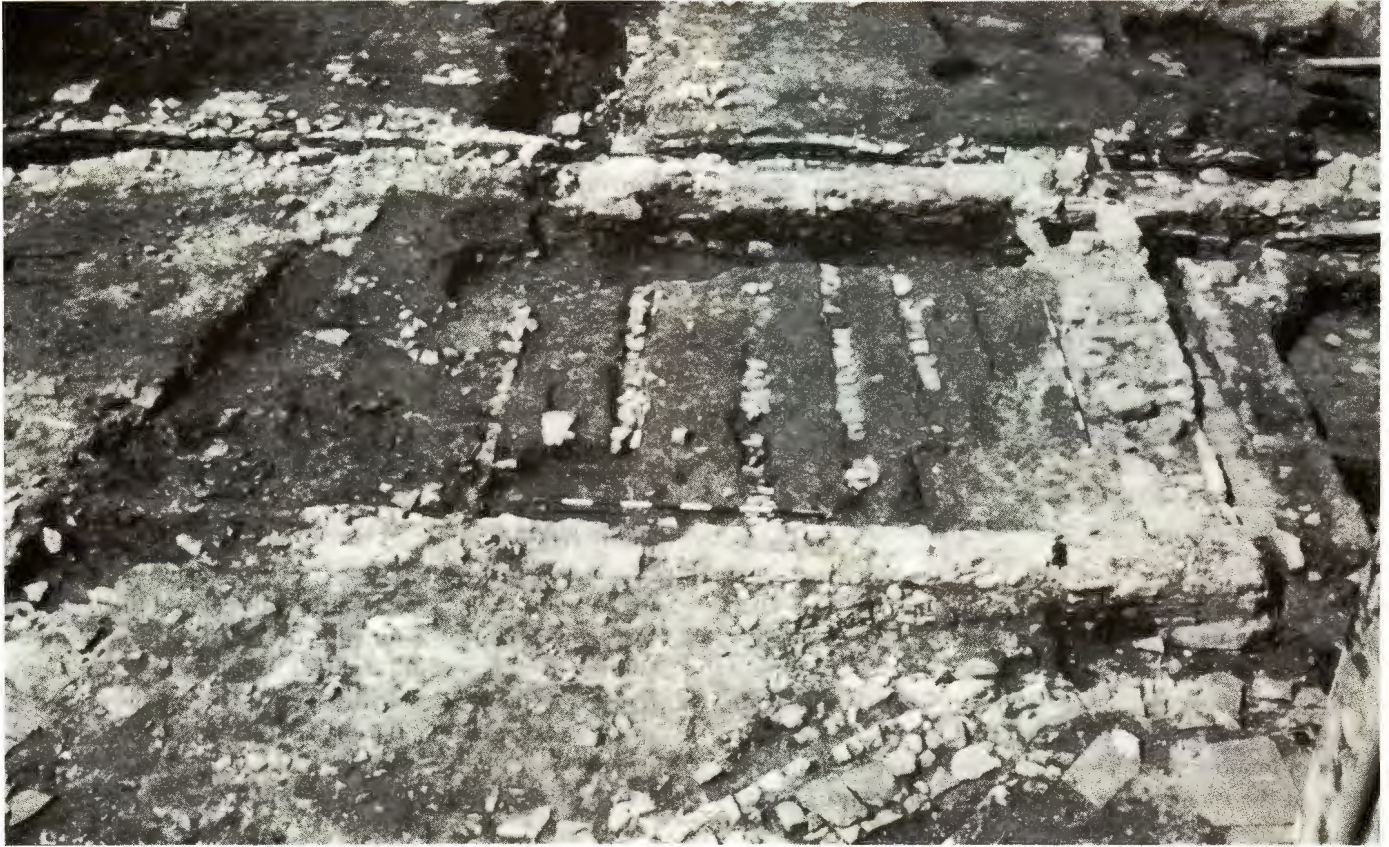
Fig. 18 Vicarage (B3). Phase III — East part of the building showing the foundations of the floor joists. Scales 2m.

This was the latest phase to leave any trace of floor levels, and these were only in evidence in the eastern part of the building. To the east of G46 the make-up was of orange mortarly soil, cut by a series of stone-filled slots criss-crossing the room (Fig. 18). These slots were the foundations for joists to support a wooden floor. The make-up was covered by a thin layer of white mortar, which also partially covered the slots, but the joists themselves had left their trace as charcoal-filled depressions.

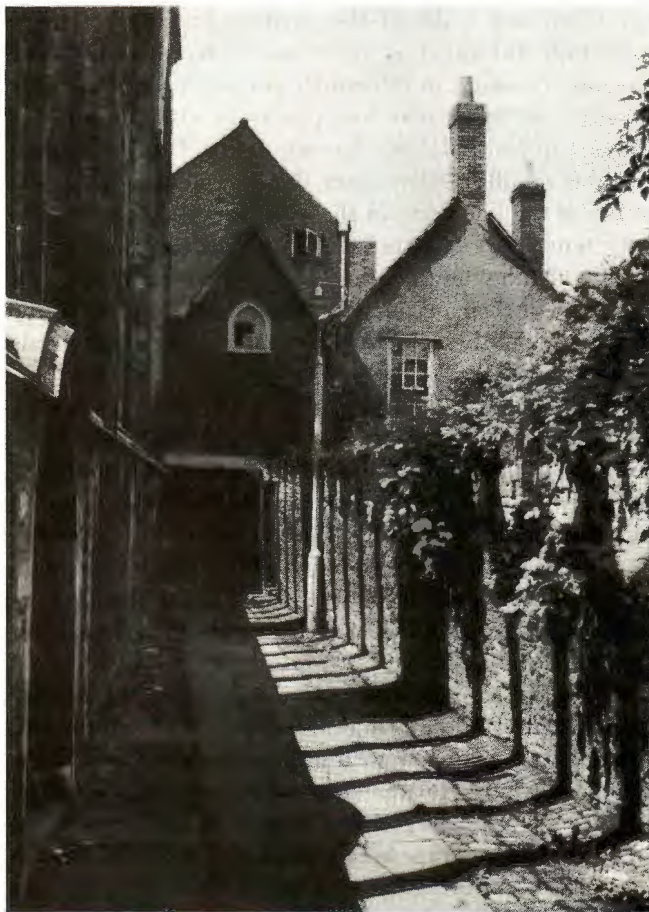
Fig. 23 Vicarage (B3) in 1969, viewed from the east along Colston Place. Note the pitches of the roofs and the extension of the first floor across the lane. Photograph courtesy of RCHM.

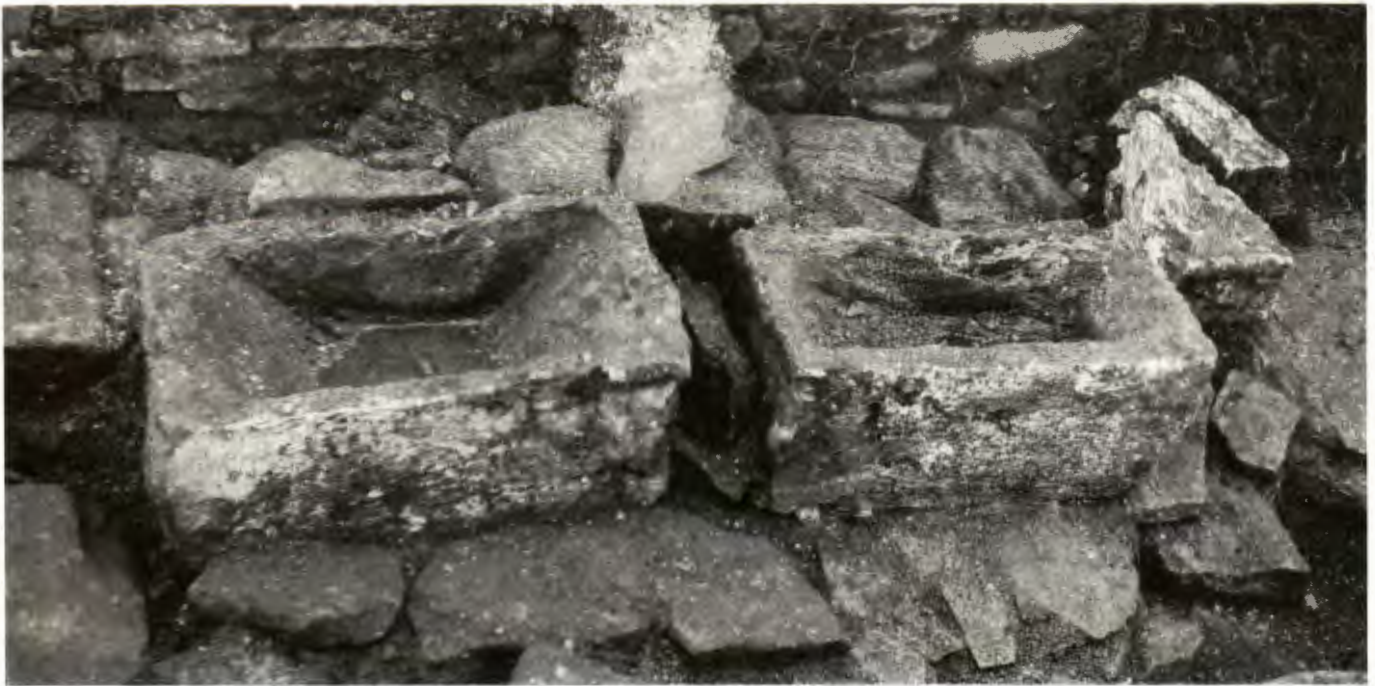
Fig. 24 Vicarage garden —Privy in building B2. Stone troughs above drain D1. These served as traps beneath water closets to hold back smells from the drain.
